**TRANSPORTATION SCIENCES CENTER  
ACCIDENT RESEARCH GROUP**

**CALSPAN CASE NO. CA94-31**

**VEHICLE #1 - 1992 TOYOTA CAMRY LE  
DRIVER SIDE AIR BAG  
DRIVER FATALITY**

**ON-SITE INVESTIGATION**

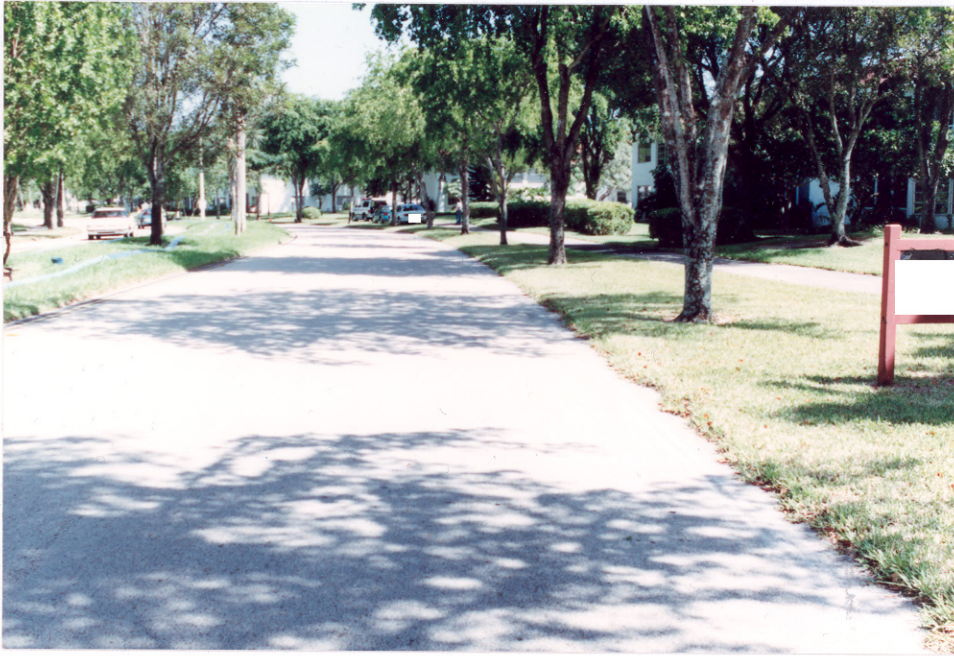
1. Trajectory of Vehicle #1, 1992 Toyota Camry LE, 90 m (300') west of the point of impact (POI).

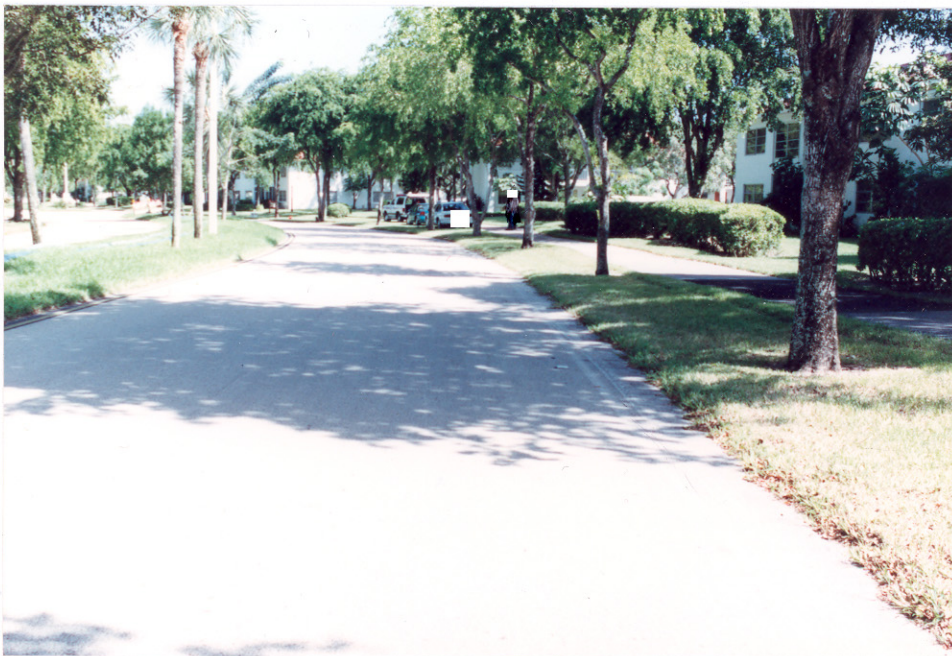
2. Trajectory of Vehicle #1, 75 m (250') from the POI.

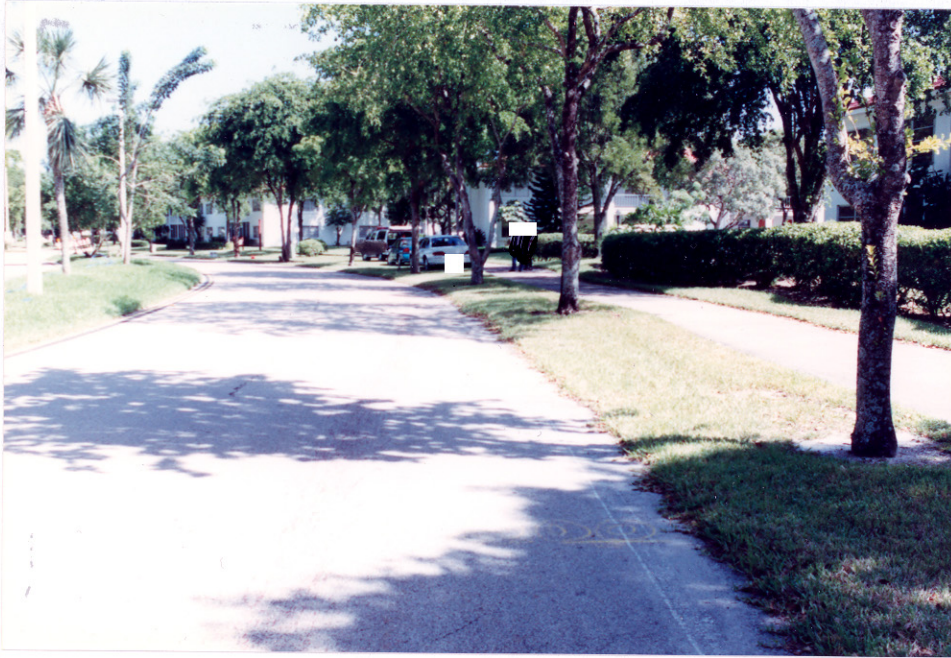
3. Trajectory of Vehicle #1, 60 m (200') from the POI.

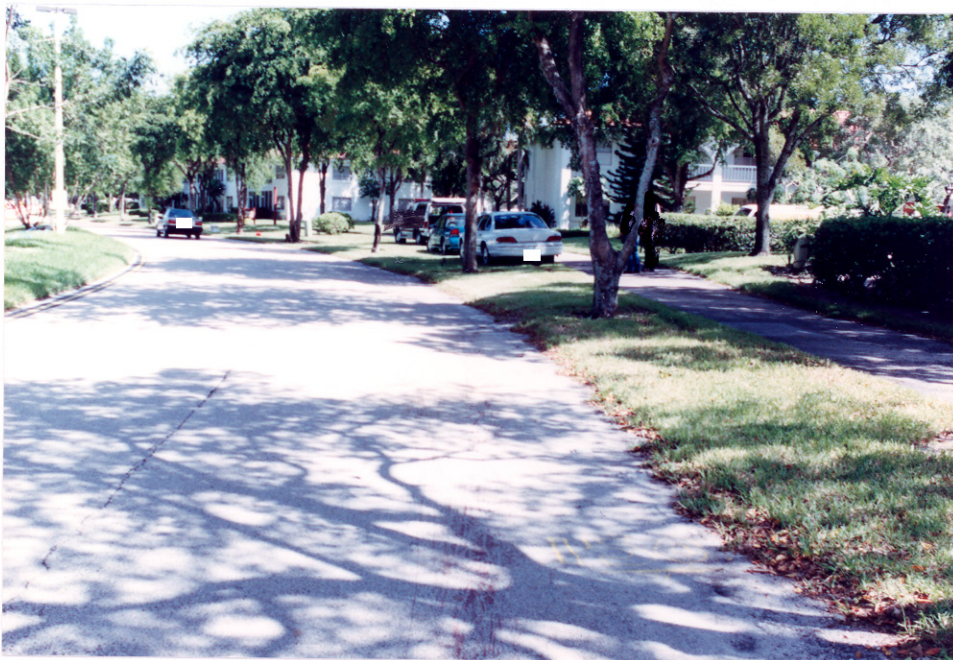
4. Trajectory of Vehicle #1, 45 m (150') from the POI.

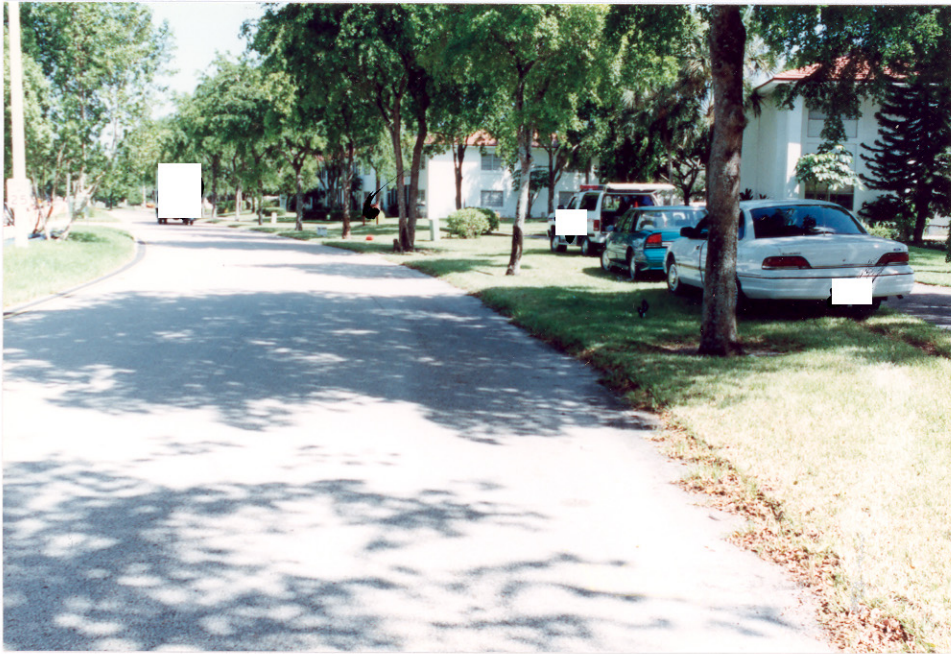
5. Trajectory of Vehicle #1, 30 m (100') from the POI.

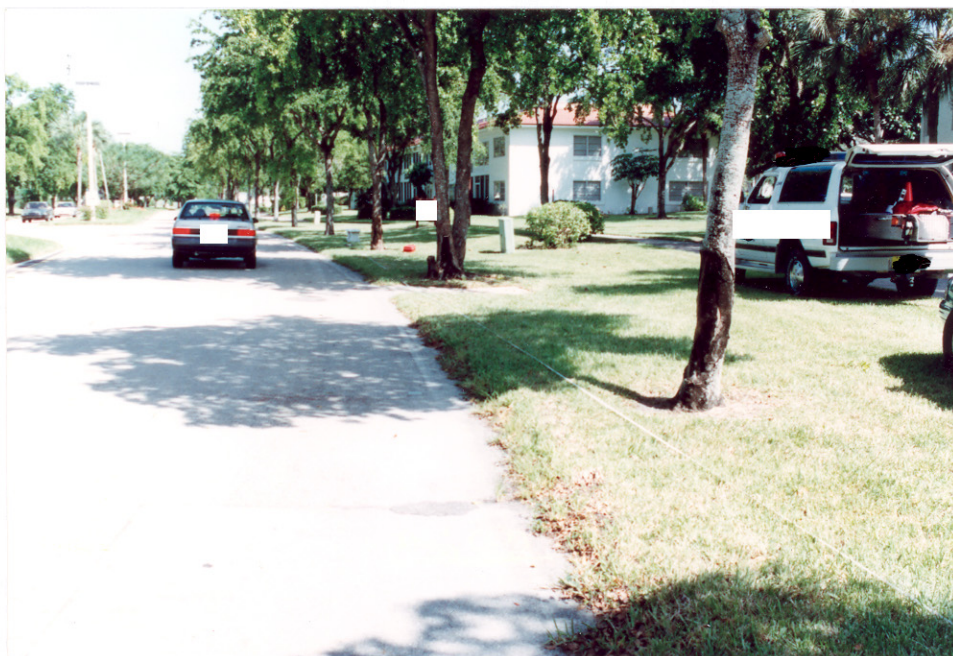
6. Trajectory of Vehicle #1, 15 m (50') from the POI.

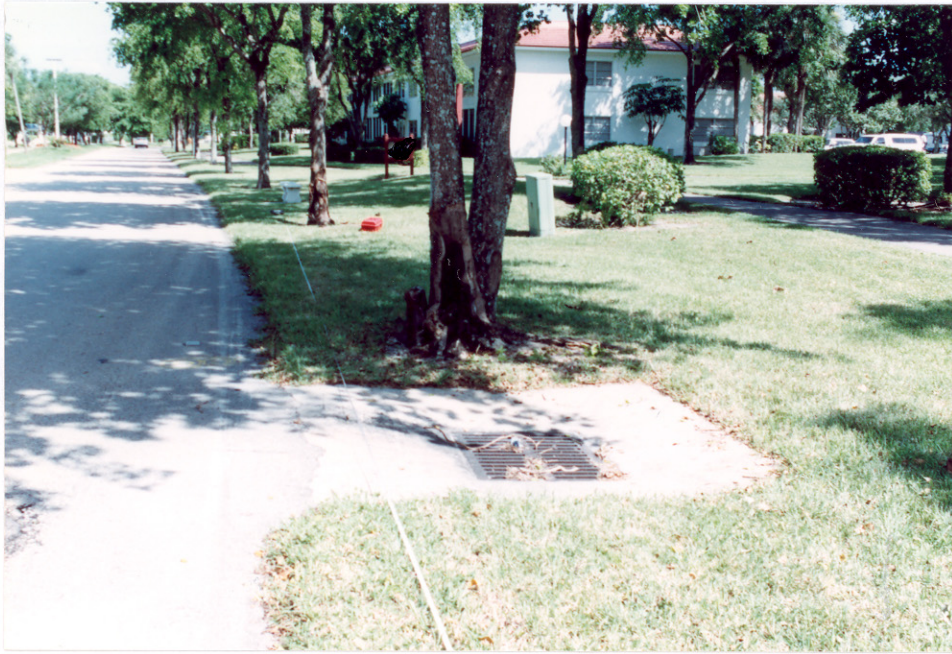
7. Trajectory of Vehicle #1, 3 m (10') from the POI.

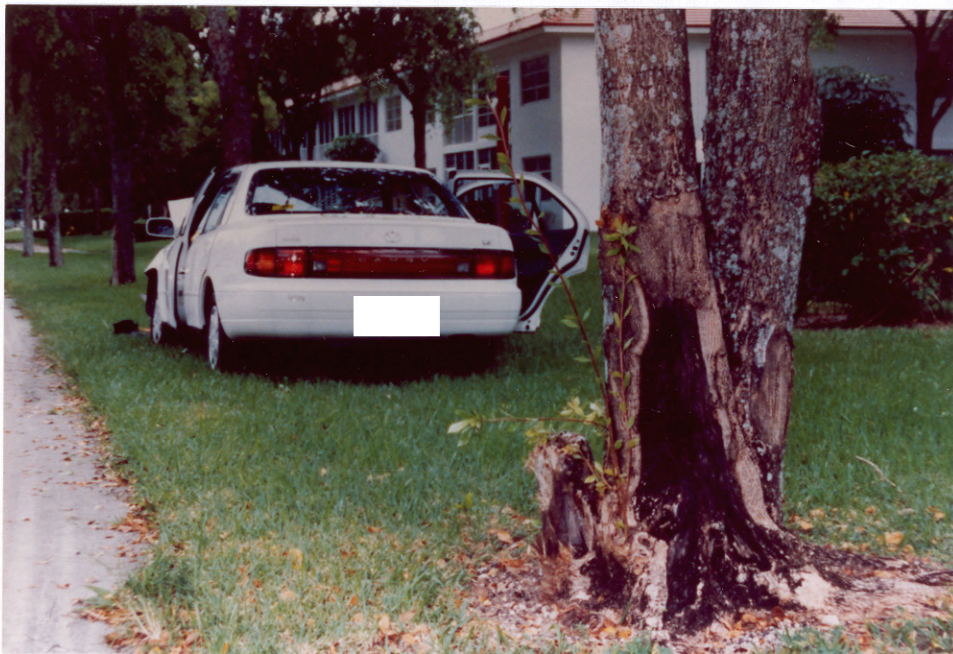
9. On-scene photograph of Vehicle #1 10.5 m (35') prior to the impact with the second tree.

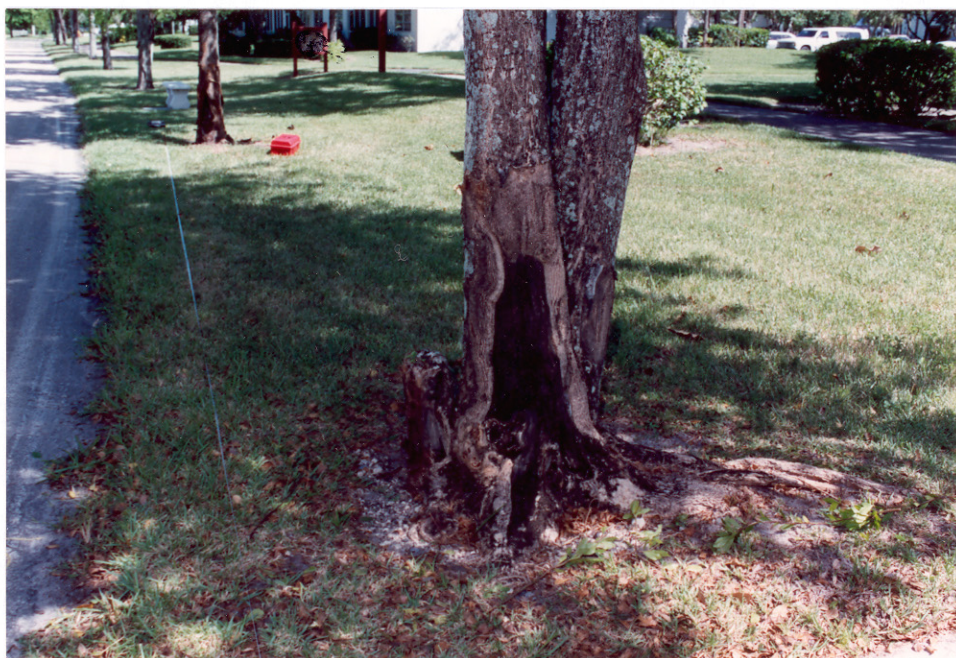
10. Same view as Photograph #9. taken during the follow-on investigation.

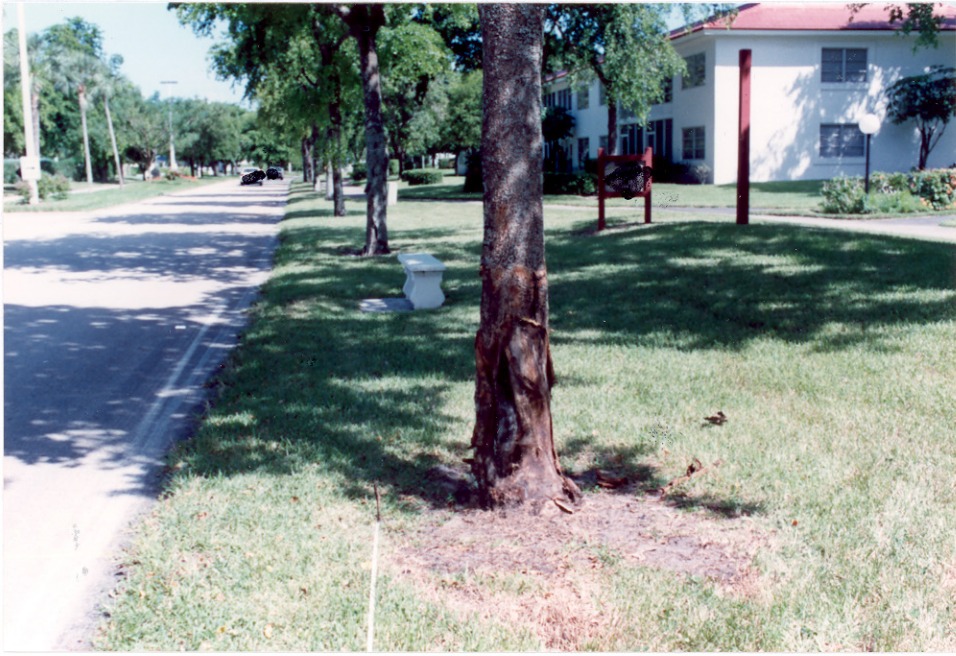
11. Post impact trajectory 2.1 m (7.0') prior to the vehicle's impact with the second tree.

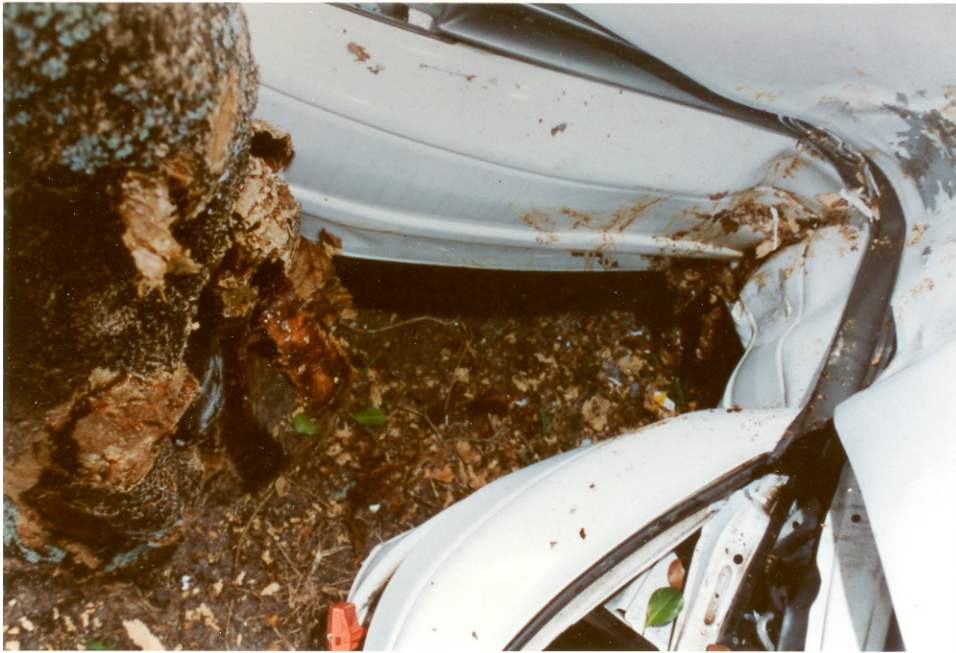
13. On-scene view of Vehicle #1's final rest position (FRP) showing the relative position of the vehicle's front bumper with the tree.

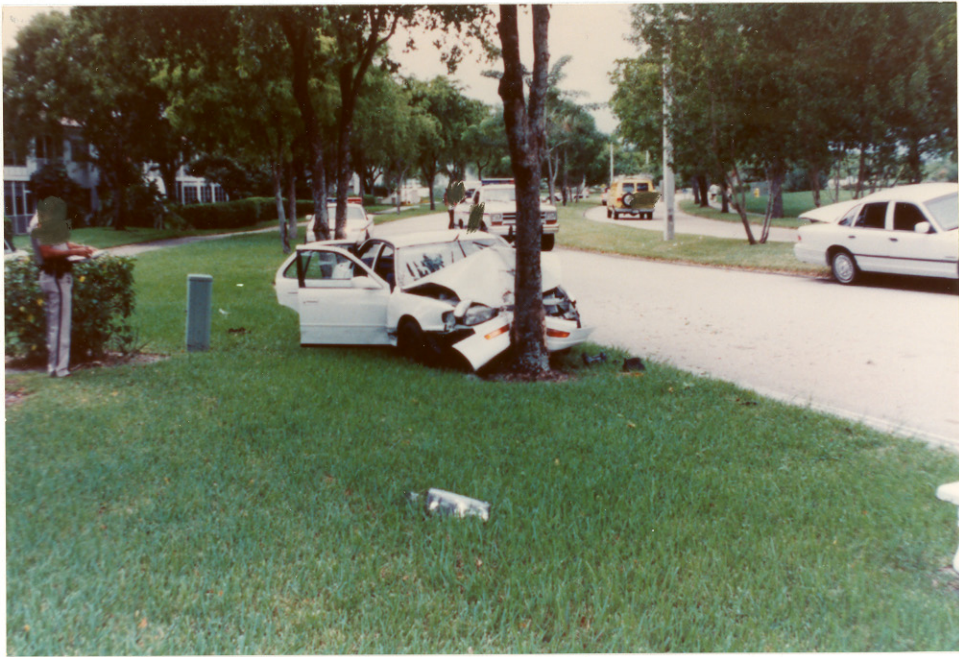
15. On-scene view of Vehicle #1's reverse trajectory.

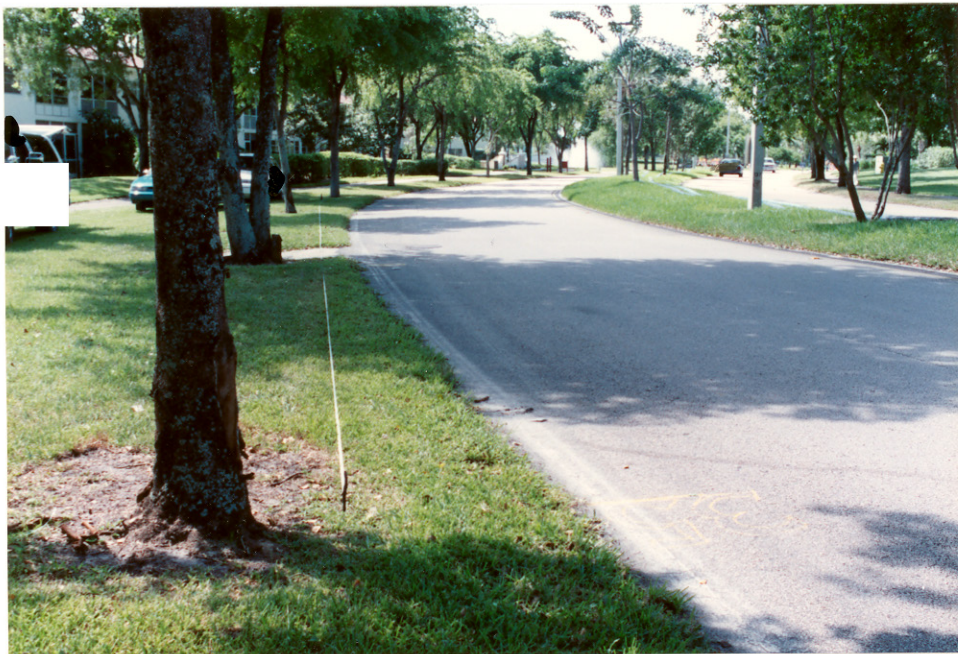
16. Reverse view of Vehicle #1's trajectory showing the second tree impact and area of the FRP.

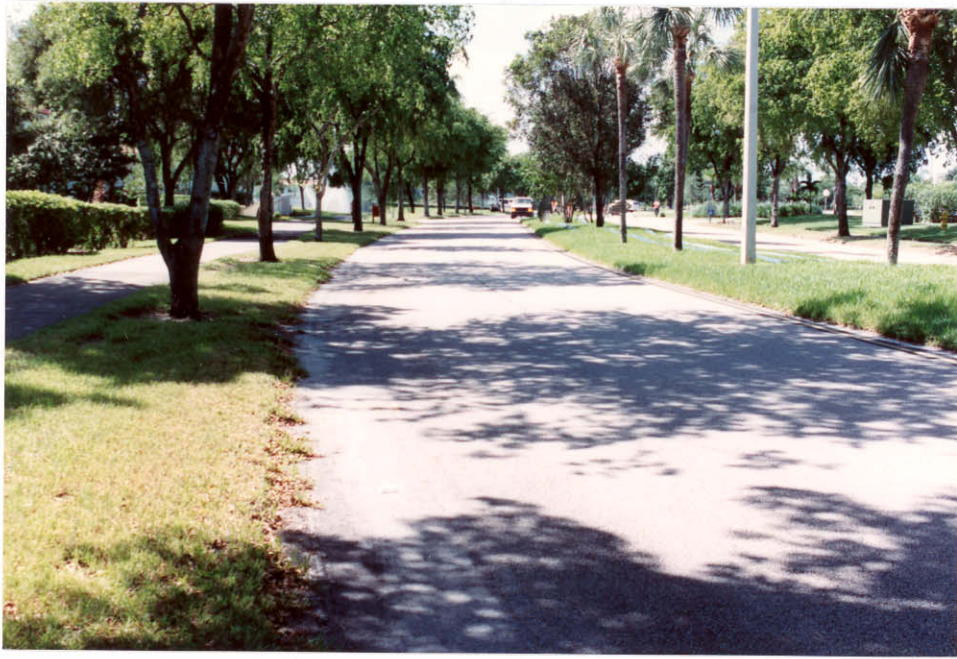
17. Reverse view of Vehicle #1's trajectory 46 m (150') west of the POI.

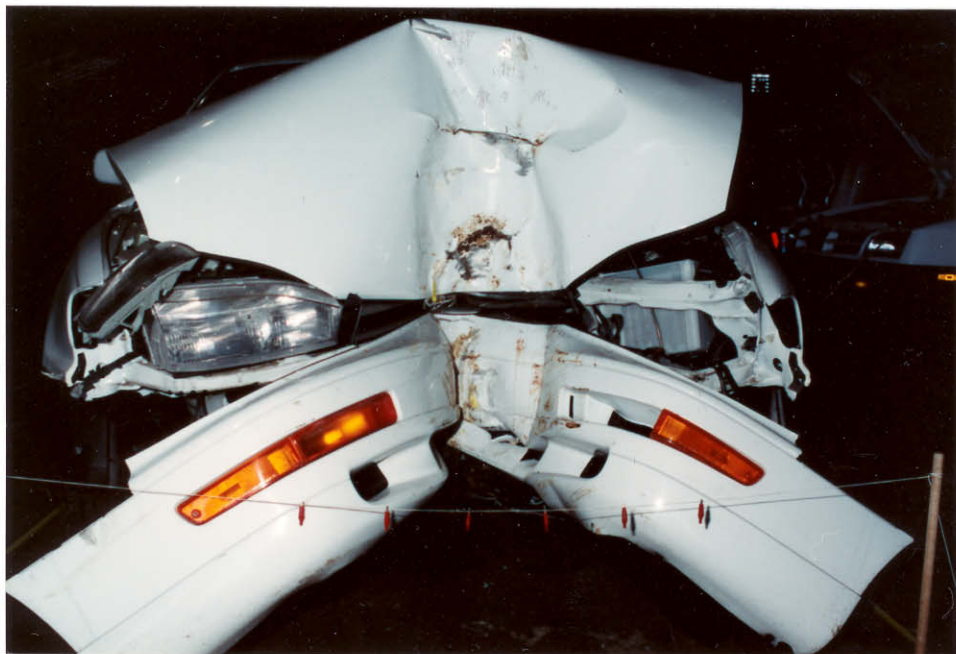
The second impact sequence involved the frontal plane of the vehicle and a 28.3 cm (11.1") diameter black olive tree. Direct contact began 7.6 cm (3.0") right of the vehicle centerline and displaced the bumper rearward 78.5 cm (30.9") at maximum crush. Components damaged in the crash included: the bumper; grille; hood; both front fenders; radiator; left and right headlight assemblies; windshield; and roof (refer to photographs #18-#32 on pages A-9 through A-16). The left side wheelbase was reduced in length by 13.0 cm (5.1") and the right side wheel base was reduced 2.0 cm (0.8").

18. Frontal view of the 1992 Toyota Camry LE showing the impact with the second tree.

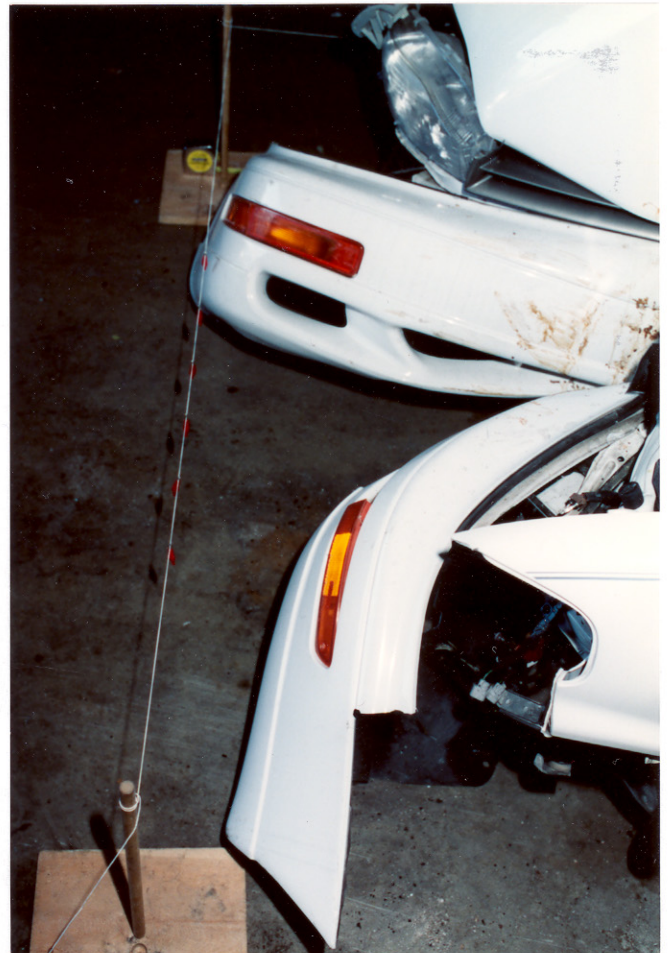
20. Lateral view of the frontal plane taken from the left side of the vehicle showing the depth of crush.

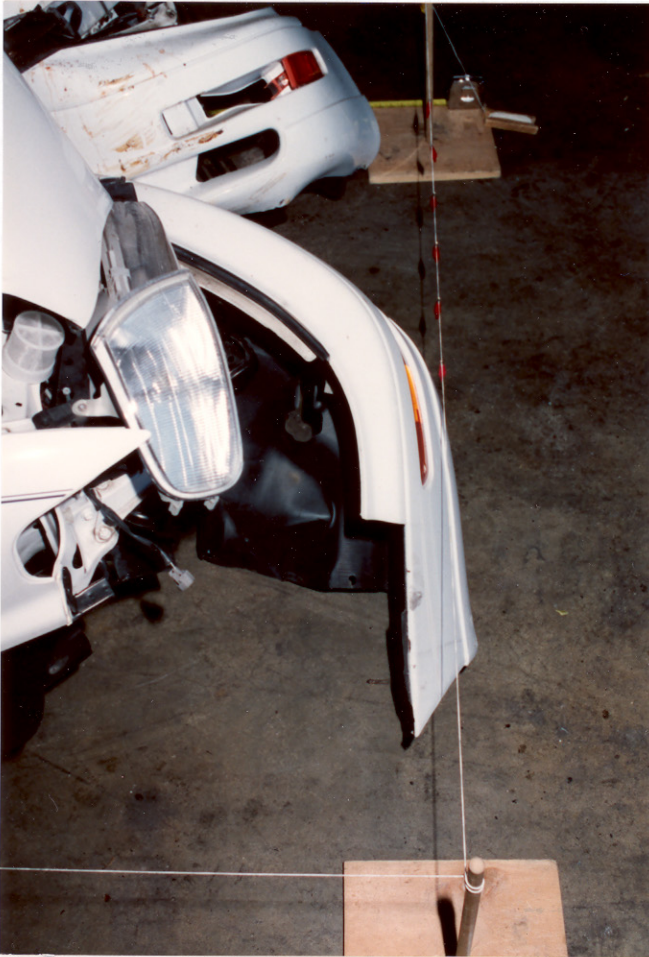
21. Lateral view of the frontal plane taken from the right side of the vehicle showing the depth of crush.

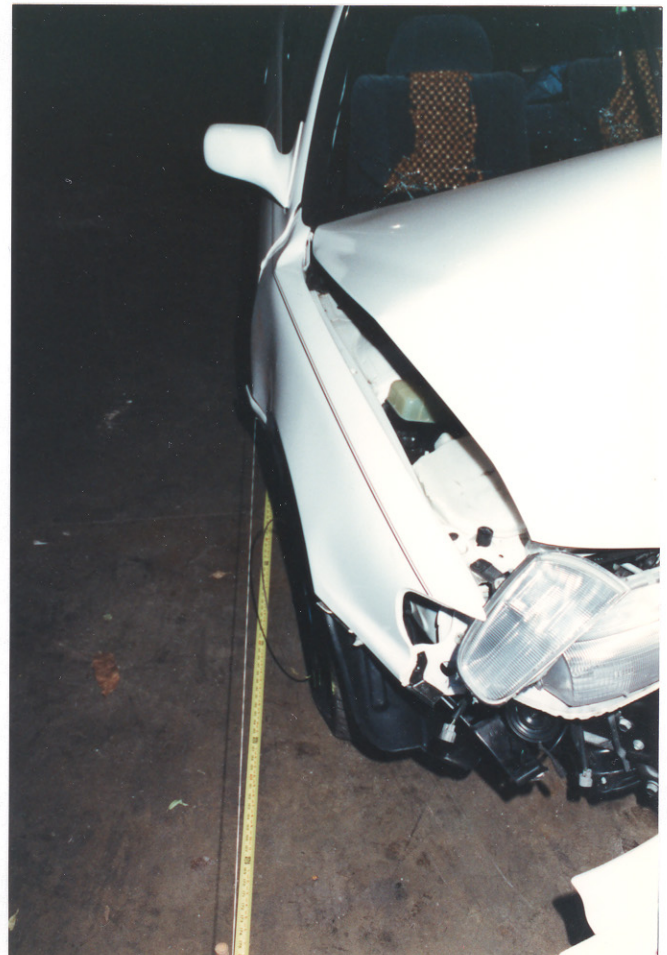
22. Longitudinal view of the right side plane taken from the front showing lateral displacement of the right front fender.

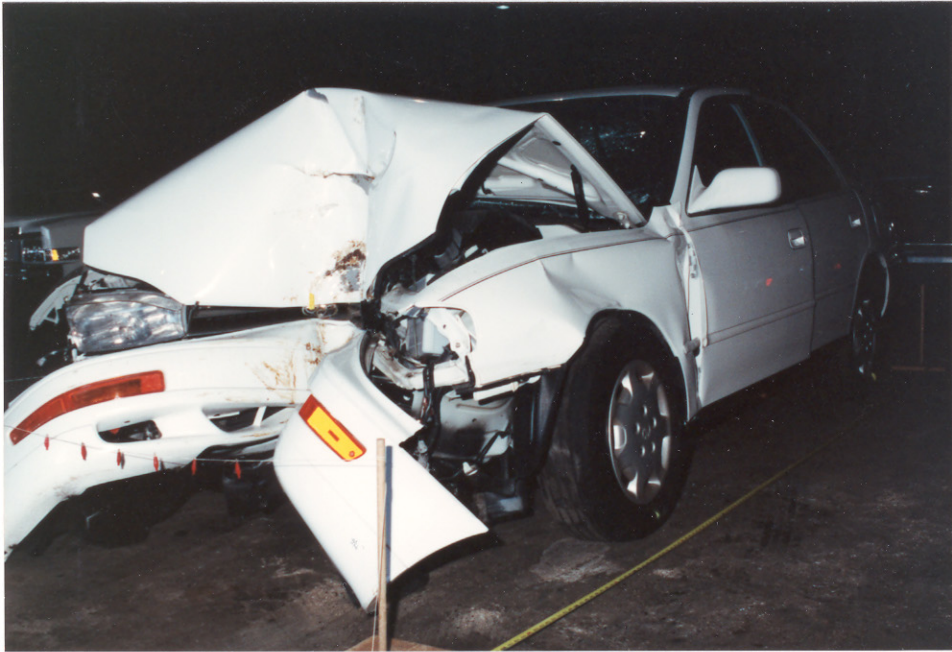
23. View of the left corner highlighting the frontal crush pattern.

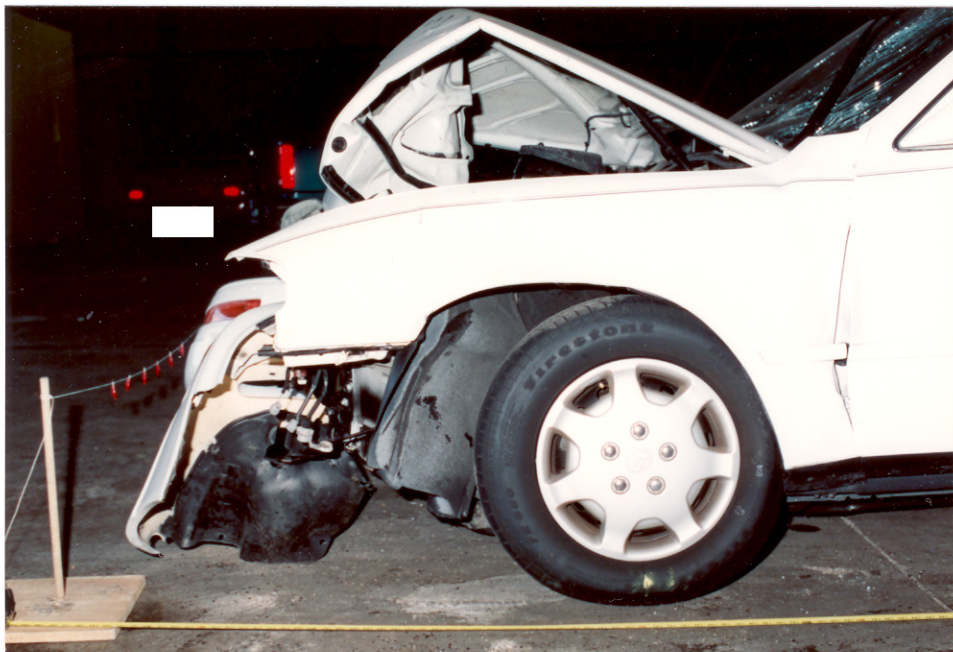
24. Lateral view of the left front fender.

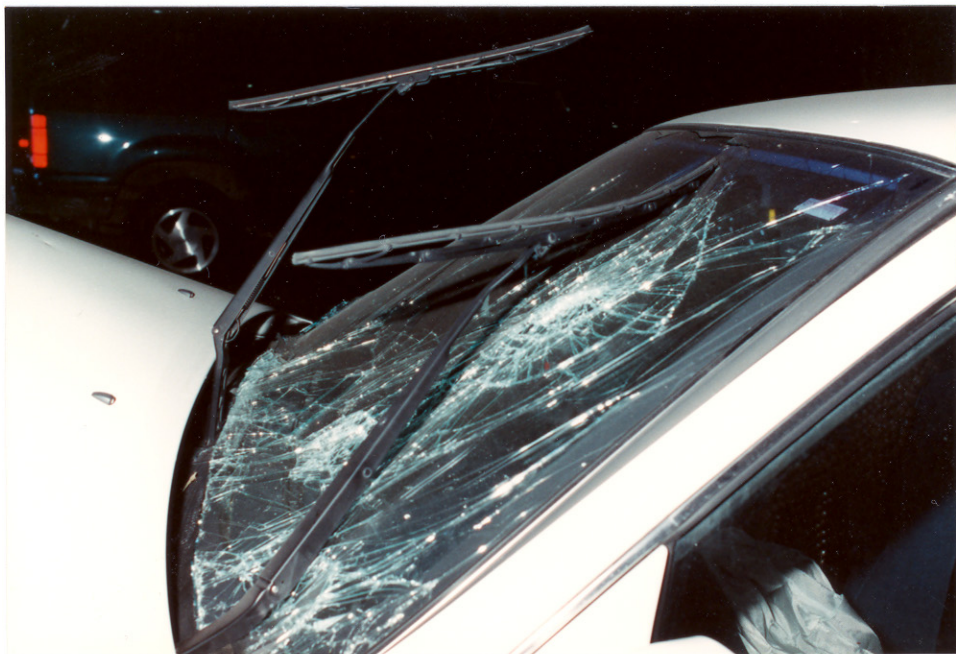
26. Lateral view of the windshield illustrating the position of the windshield wiper blades at the FRP.

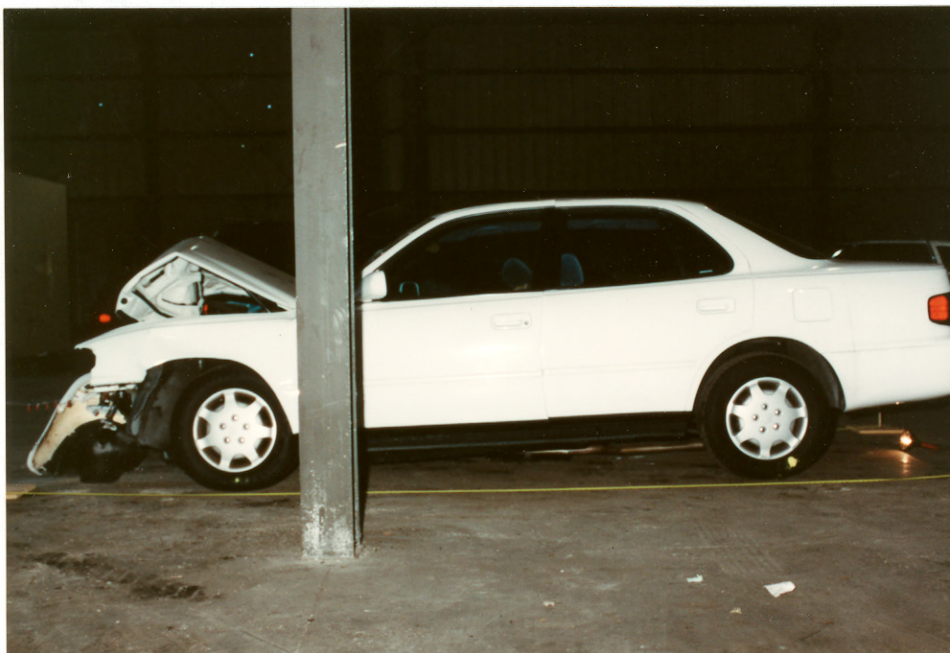
27. Overall view of the vehicle's left side plane.

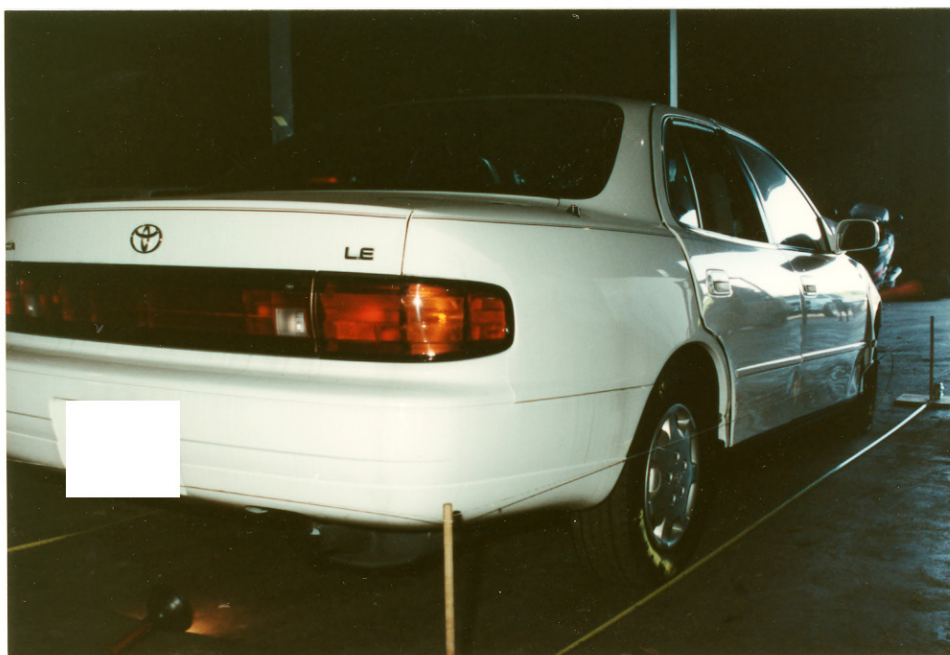
28. View of the right rear corner showing minor crush along the lower doors.

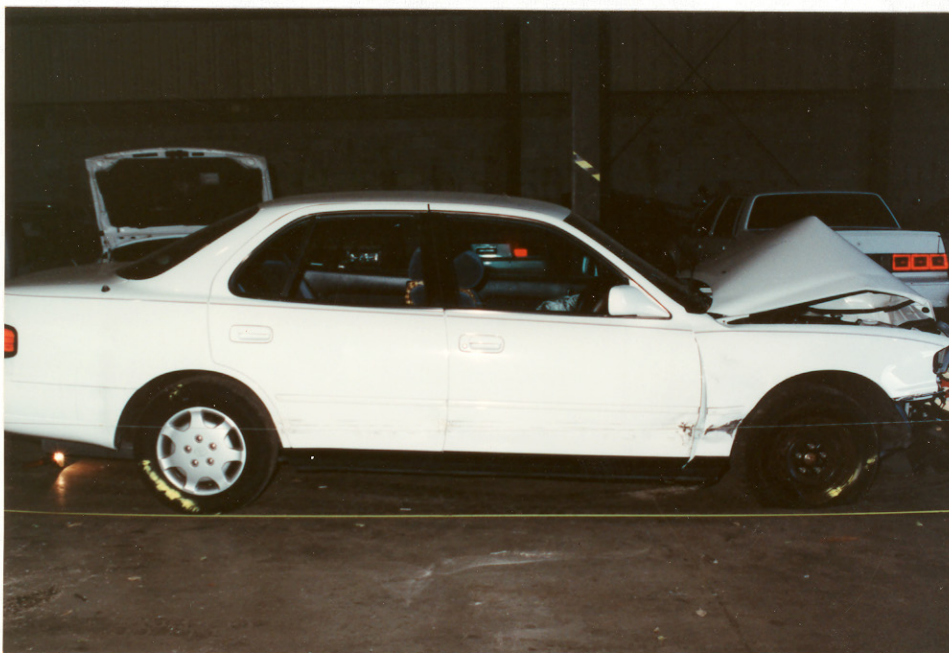
tree stump (impact #1) which began at the right front wheel and continued along the lower right side plane in a sideswipe pattern for a distance of 245.1 cm (96.5"). The contact height on the side of the vehicle measured [40.6 cm (16.0")] from the ground which was consistent with the height of the tree stump. The maximum crush for this impact was 3.8 cm (1.5") along the lower right front fender just behind the right front tire (refer to photographs #29, #30 on page A-15). Components damaged included: the right wheel and tire; the right front fender; and the right front and right rear door surfaces.

29. Overall view of the vehicle's right side plane illustrating the contact pattern which began at the right front tire and extended rearward to the rear wheel from the impact with the tree stump.

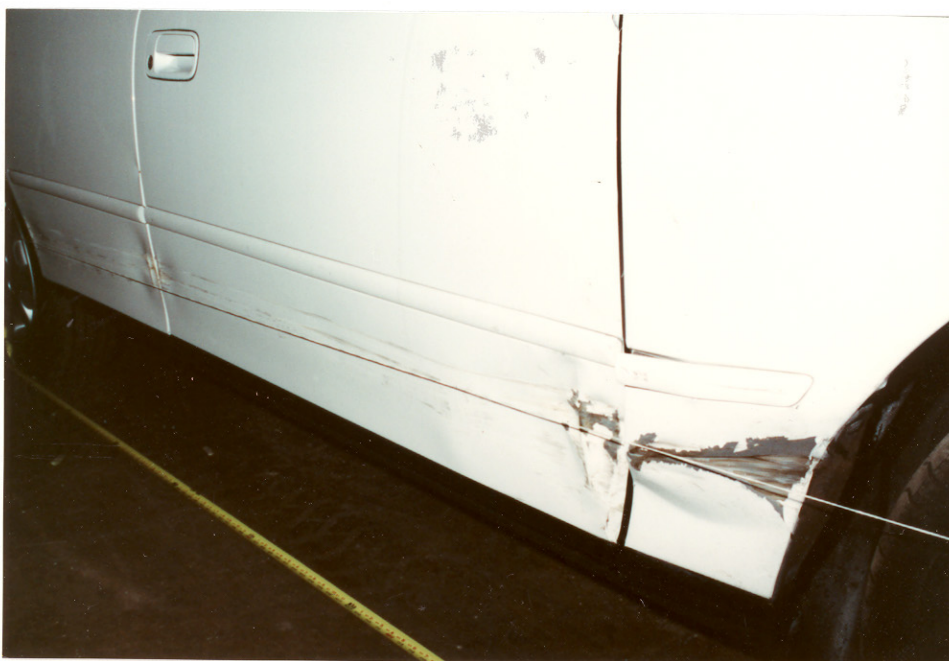
30. Closer view of the tree stump impact taken from the right front tire and looking rearward toward the right rear tire.

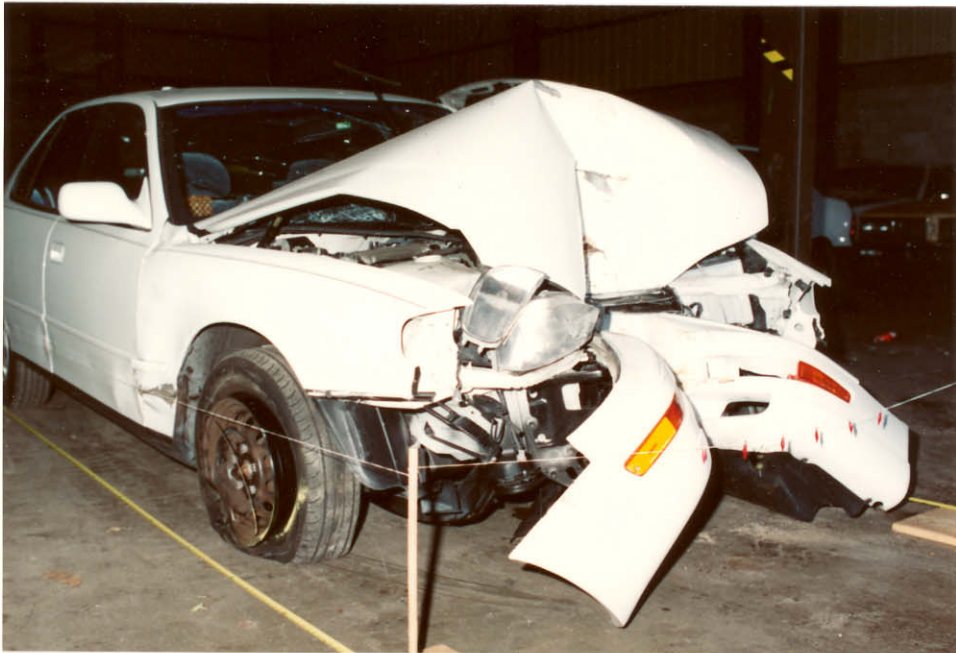
32. View of the right front corner showing frontal and right side plane impact damage.

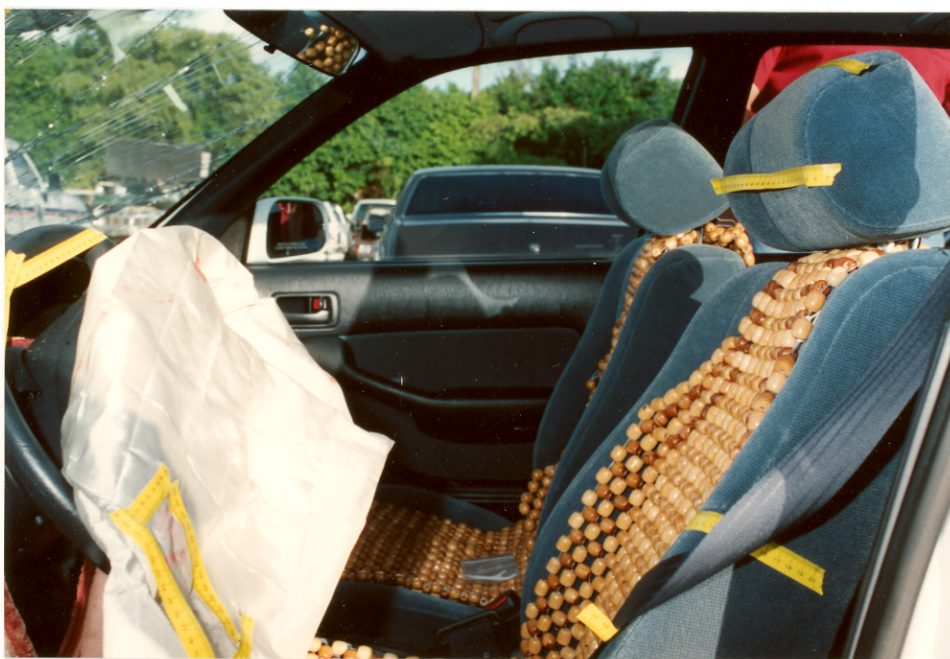
34. Lateral view of the interior taken from the driver's side and highlighting contacts on the air bag, torso belt, and head restraint, and abraded mark on seat back rest from the torso belt.

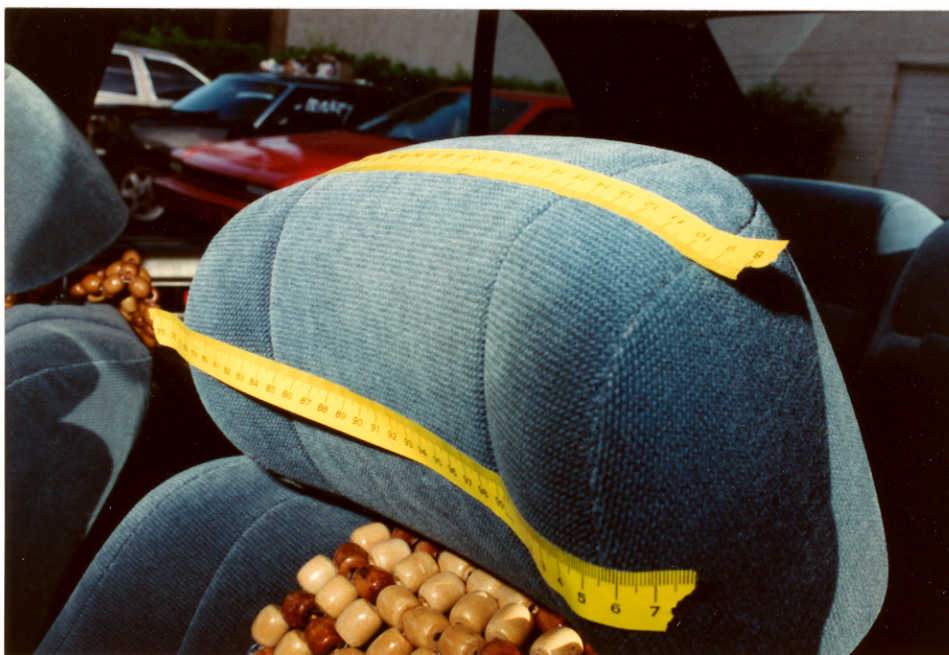
The driver rebounded rearward and contacted the seat back support and head rest. White hair fibers embedded in the fabric of the head rest was attributed to contact by the driver's head. Her upper torso then slumped forward and to the left with her head near the driver's door. Her left foot was on the floor directly in front of the seat and her right foot was in the vicinity of the accelerator pedal.

35. Close-up view of the driver's head restraint showing a light yellowish transfer from the driver's head/hair.

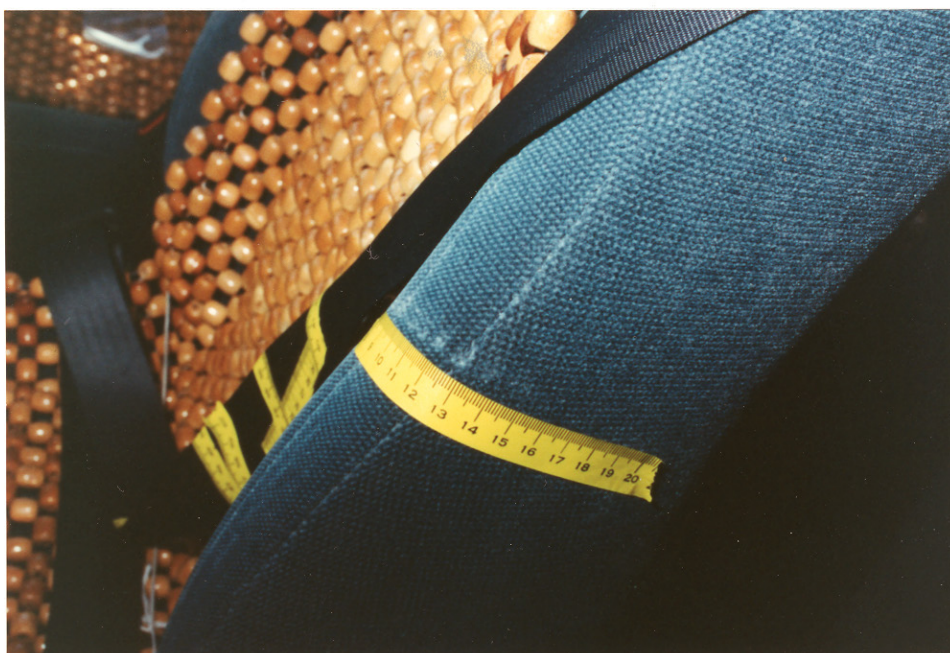
36. Close-up view of the abraded seat back fabric which was produced from the torso restraint belt during the impact with the second tree.

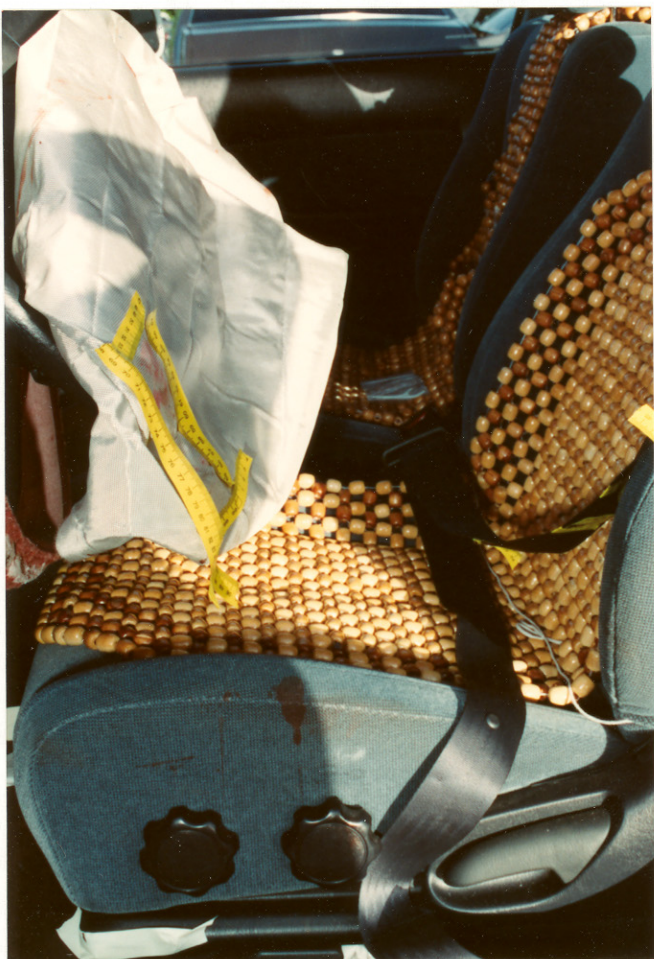
37. View of the seat placement at POI which was 15.5 cm (6.1") forward of the full rear adjustment position and 8.4 cm (3.3") rear of the full forward position.

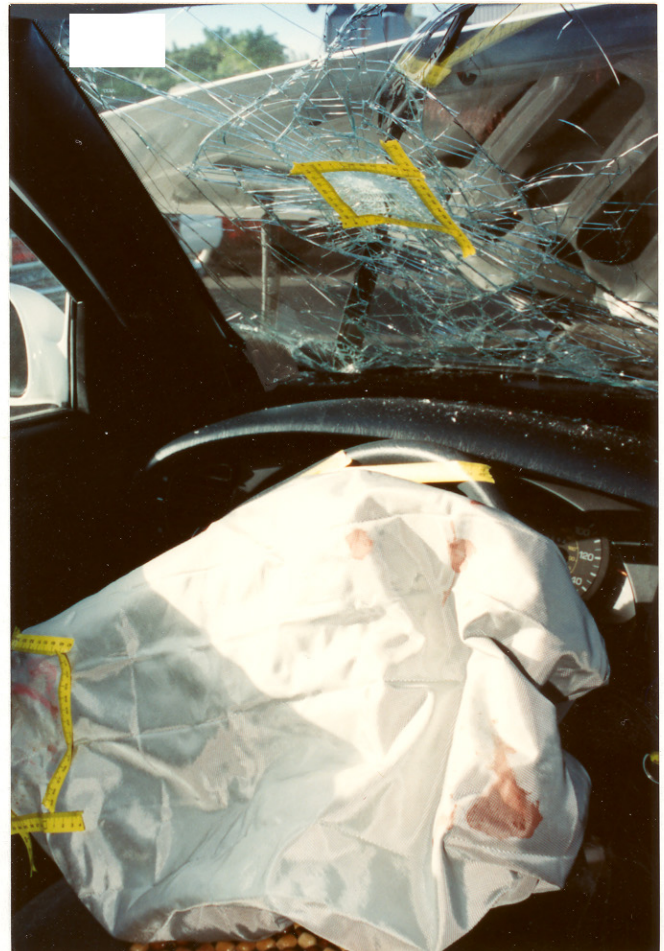
The left side of the windshield contained a typical spider web glazing fracture pattern which was the result of contact by the driver's left hand. It was located 39.4 cm (15.5") left of the vehicle centerline and 20.3 cm (8.0") above the instrument panel (refer to photograph #40, #41 on pages A-20, A-21).

40. View of the left third of the instrument panel showing contact to the windshield, steering wheel rim, and air bag.

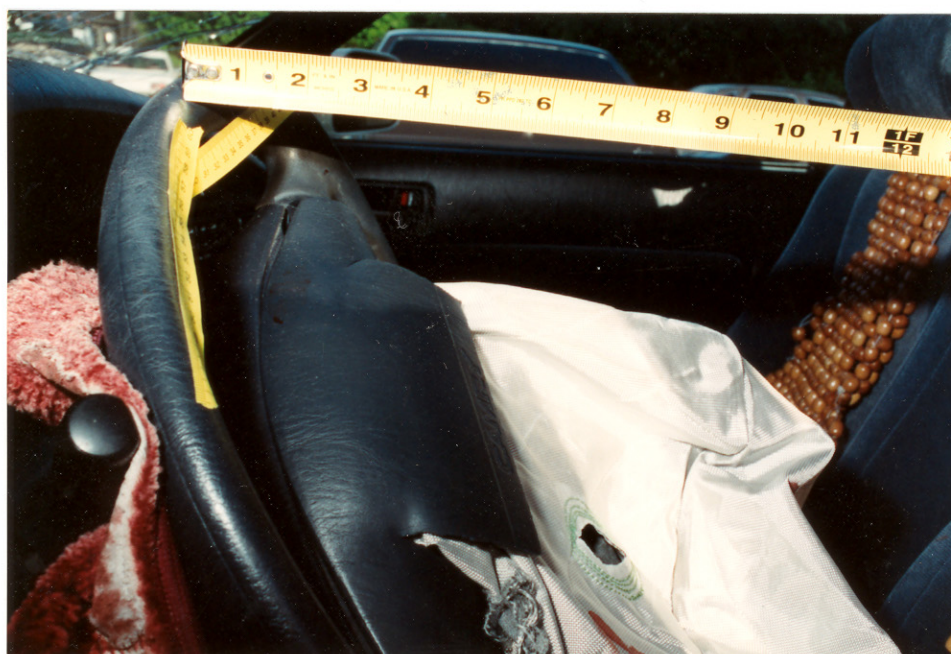
46. View of the top portion of the steering wheel which illustrates the forward displacement of the steering wheel rim.

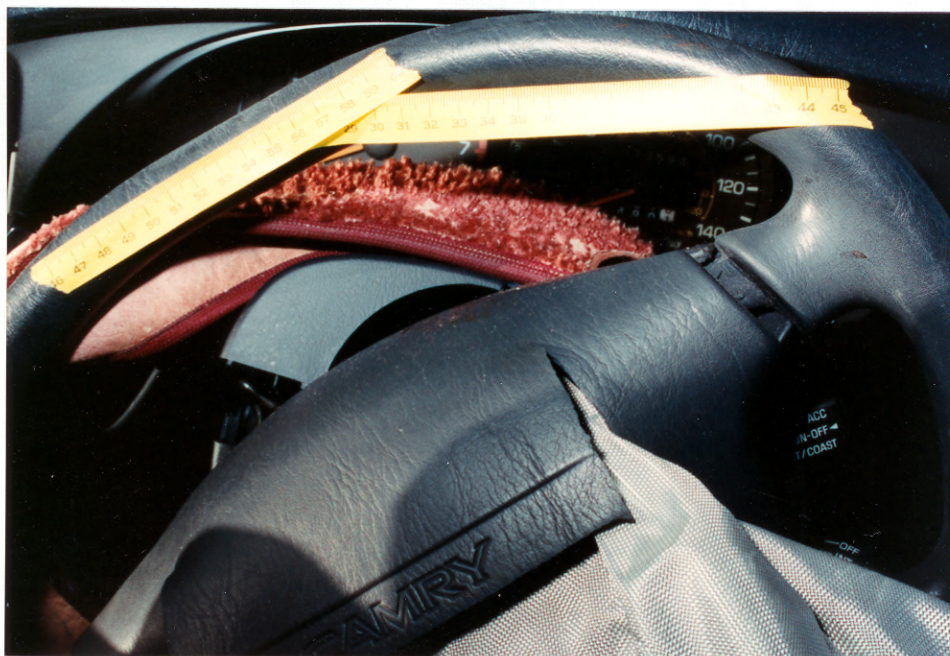
47. View of the top area of the steering wheel which illustrates driver contact and vertical displacement of the steering wheel rim.

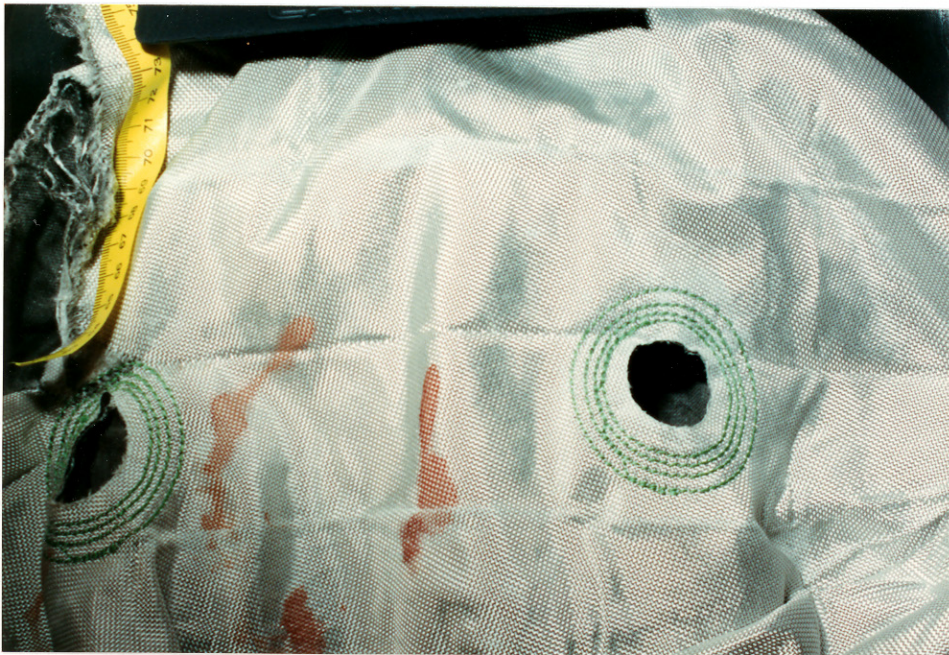
50. View of the two air bag vent ports located near the top portion of the air bag (instrument panel side of the bag).
